Supplementary Content: Image Gallery

The Functions of Masons' Marks in the Bronze Age Palace at Malia (Crete)

Maud Devolder

Published online 20 June 2018
American Journal of Archaeology Volume 122, Number 3
DOI: 10.3764/ajaonline1223.Devolder.suppl

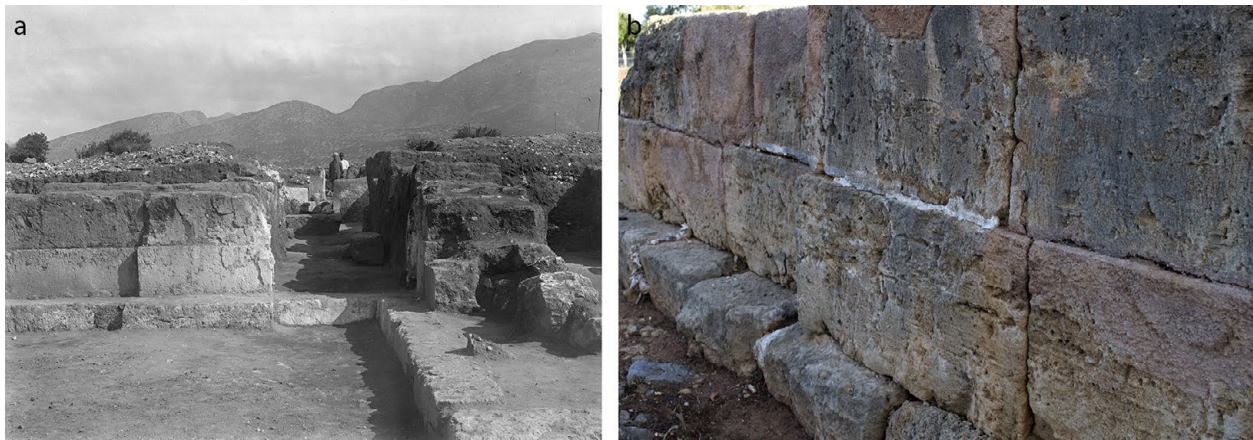
FIG. 1. Remains of plaster coating on the sandstone facade on the West Court: *a*, west facade of Rooms III 5 and I 7 during the excavations of the palace at the beginning of the 20th century, looking east (Pelon 1980, pl. 8.1; courtesy École française d'Athènes); *b*, view of plaster coating still preserved in the joints of the sandstone facade south of the West Wing (south wall of Room XX 2, looking northwest).

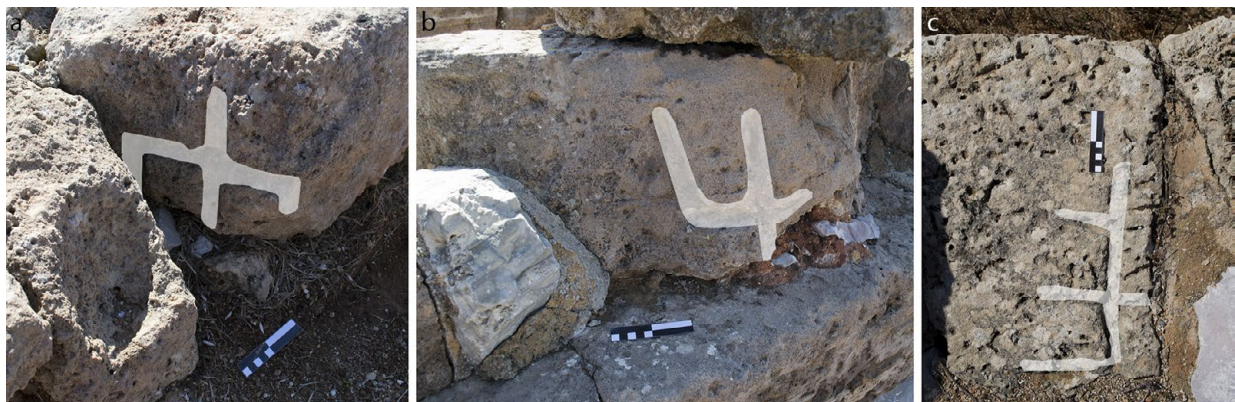
FIG. 4. Cut trident marks on *a*, Block 44; *b*, Block 40; *c*, Block 50 . The marks are highlighted in white.

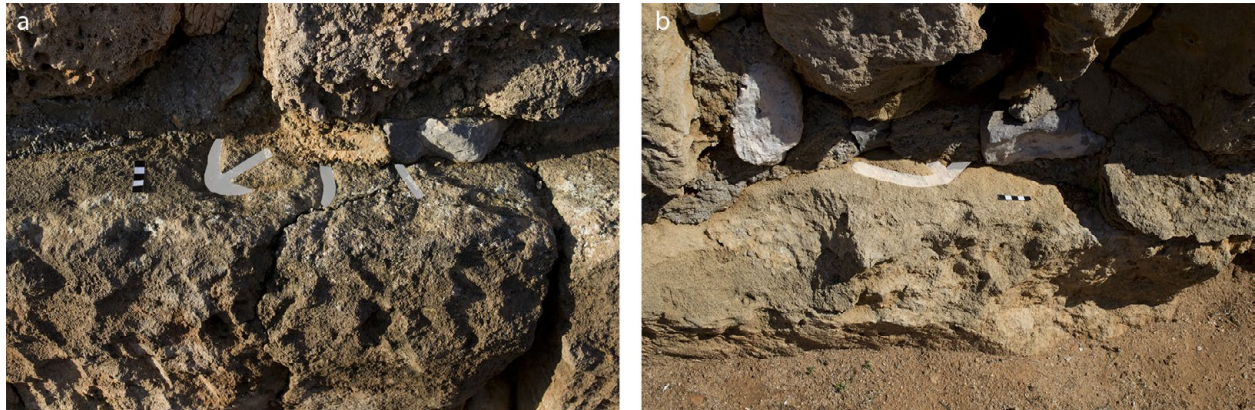
FIG. 5. Partly hidden masons' marks: *a*, on Block 35 in the north wall of Room I 6; *b*, on Block 38 in the south wall of Room I 5. The marks are highlighted in white.

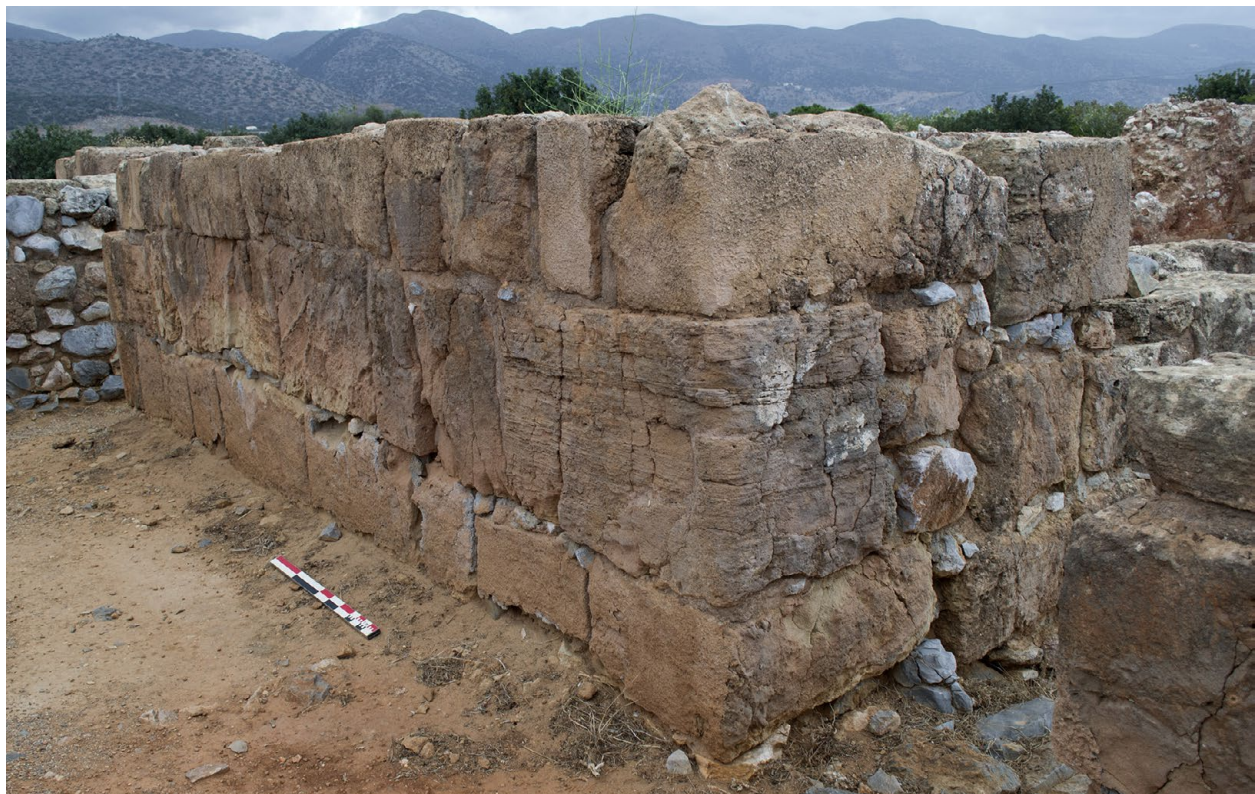
FIG. 6. Elaborate sandstone ashlar masonry in Area VII (west wall of Room VII 6, looking southwest), showing the careful positioning of the blocks.
